**VinFast VF8**  
Standard Safety Equipment

2023

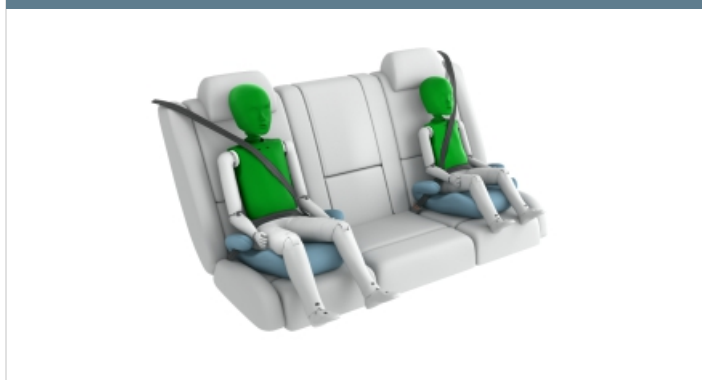
Frontal Impact 16 Pts

Crash Test Performance based on 6 & 10 year old children

24.0 / 24 Pts

In both the frontal offset and side barrier tests, good protection was provided to all critical body areas for both child dummies, and the VinFast VF8 scored maximum points in this part of the assessment. The VinFast is equipped with automatic disabling of the front passenger airbag to allow a child restraint to be used in that seating position. VinFast demonstrated that the system operated robustly and the system was rewarded. The VF8 is equipped with 'child presence detection', a system which issues a warning when it recognises that a child or infant has been left in the car. However, VinFast could not demonstrate to Euro NCAP's satisfaction that all requirements were met, and the system was not rewarded. All of the child restraint types for which the VF8 is designed could be properly installed and accommodated in the car.

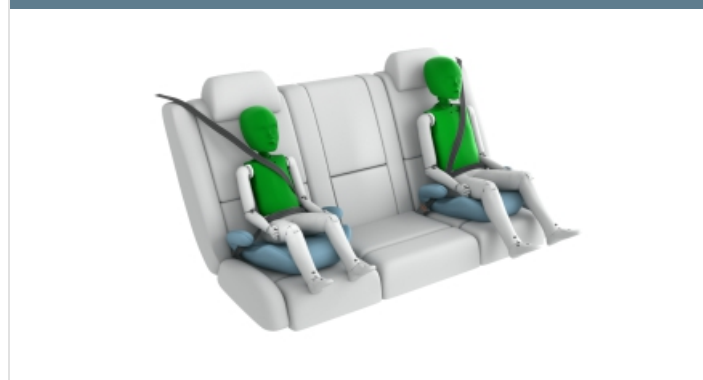
Lateral Impact 8 Pts

Restraint for 6 year old child: *Britax Römer Kidfix i-Size*  
 Restraint for 10 year old child: *Graco Booster Basic*
